VILLAGE OF CLARENDON HILLS

April 18, 2013 Storm Event

**Clarendon Hills, DuPage
County, Illinois**

CBBEL Project No. 13-0200

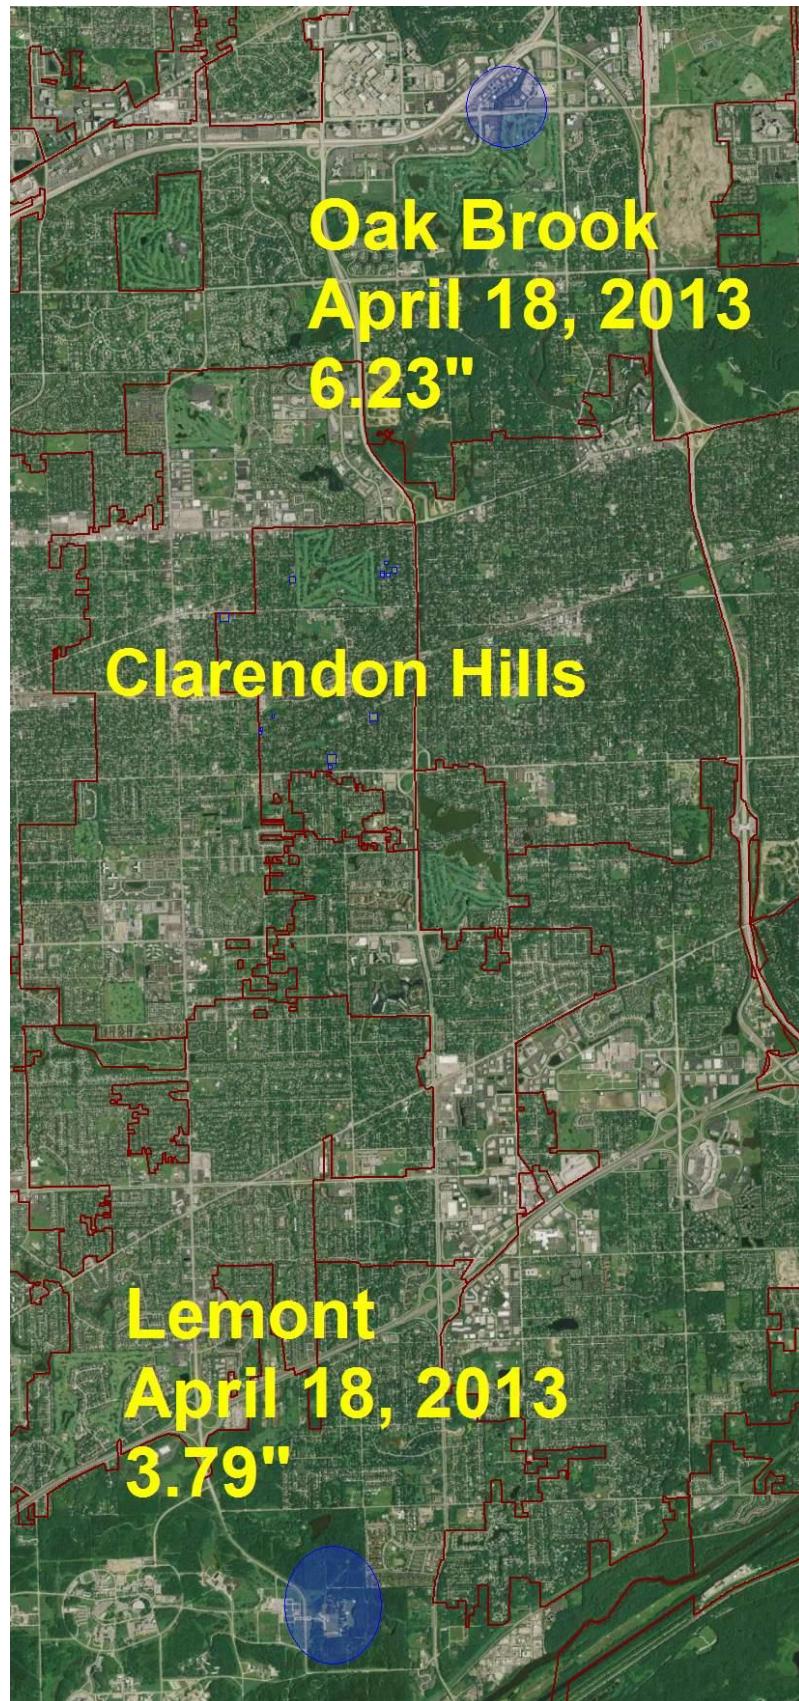
Figure 1 - April 18, 2013 Rainfall Totals

Based on the reported street inundation depths and the inundation timing, it is our opinion that the Village experienced rainfall closer what was reported at the Oak Brook rainfall gage.
