VILLAGE OF CLARENDON HILLS

April 18, 2013 Storm Event

**Clarendon Hills, DuPage
County, Illinois**

CBBEL Project No. 13-0200

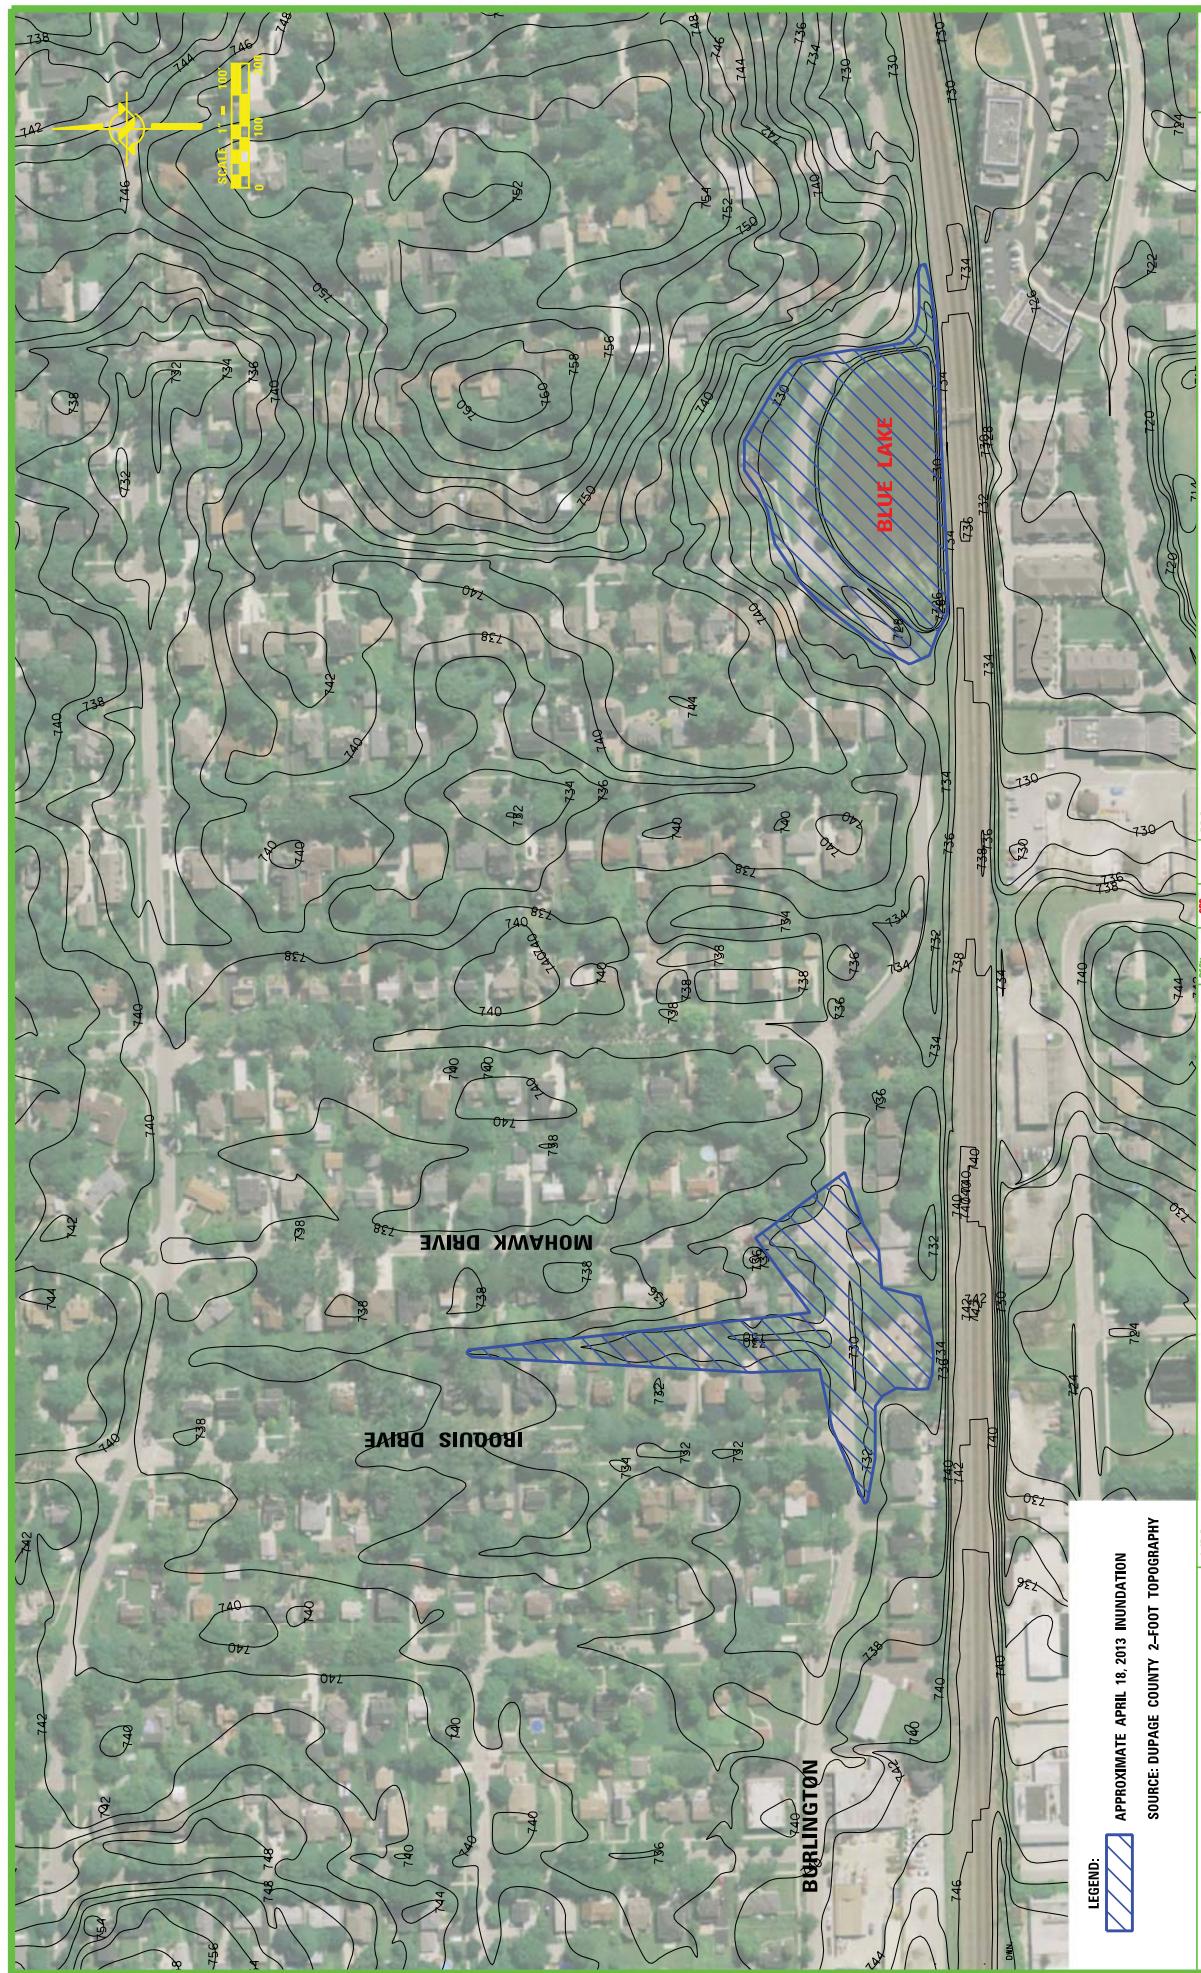
EXHIBIT 5

This 225 acre subwatershed drains to Blue Lake. This subwatershed area includes 110 acres located within the Village of Westmont. The collected stormwater in Blue Lake is conveyed southward under the railroad tracks into the Park Avenue storm sewer. This storm sewer is also the outlet for the Park Avenue stormwater basin. Within the subwatershed, stormwater flows north to south towards Burlington Avenue and then eastward to Blue Lake. The ability for Blue Lake to discharge stormwater is limited when the Park Avenue storm sewer fills. Blue Lake will exceed its capacity flooding Burlington Avenue and backing up stormwater to the west. Low lying street sags will fill with stormwater which reaches elevations which result in yard flooding and then home flooding.

A XP-SWMM hydrologic and hydraulic model was previously developed for the Flagg Creek watershed by DuPage County. This model will be enhanced to show more detail in the areas of known flooding problems. The model will be calibrated using the surveyed April 18, 2013 HWMS. The calibrated model will be used to evaluate potential flood mitigation alternatives including expansion of the storage within the existing stormwater basins (Dallas Street, Park Avenue, Blue Lake and Hosek Park). The expansion of the Hosek Park stormwater basin would allow the potential for better drainage for the N. 55th Street area and to accommodate outflows from the Dallas Street stormwater basin. For the area on Burlington Avenue, potential storage options will be evaluated. Non-structural measures (floodproofing and buyout) will also be evaluated.

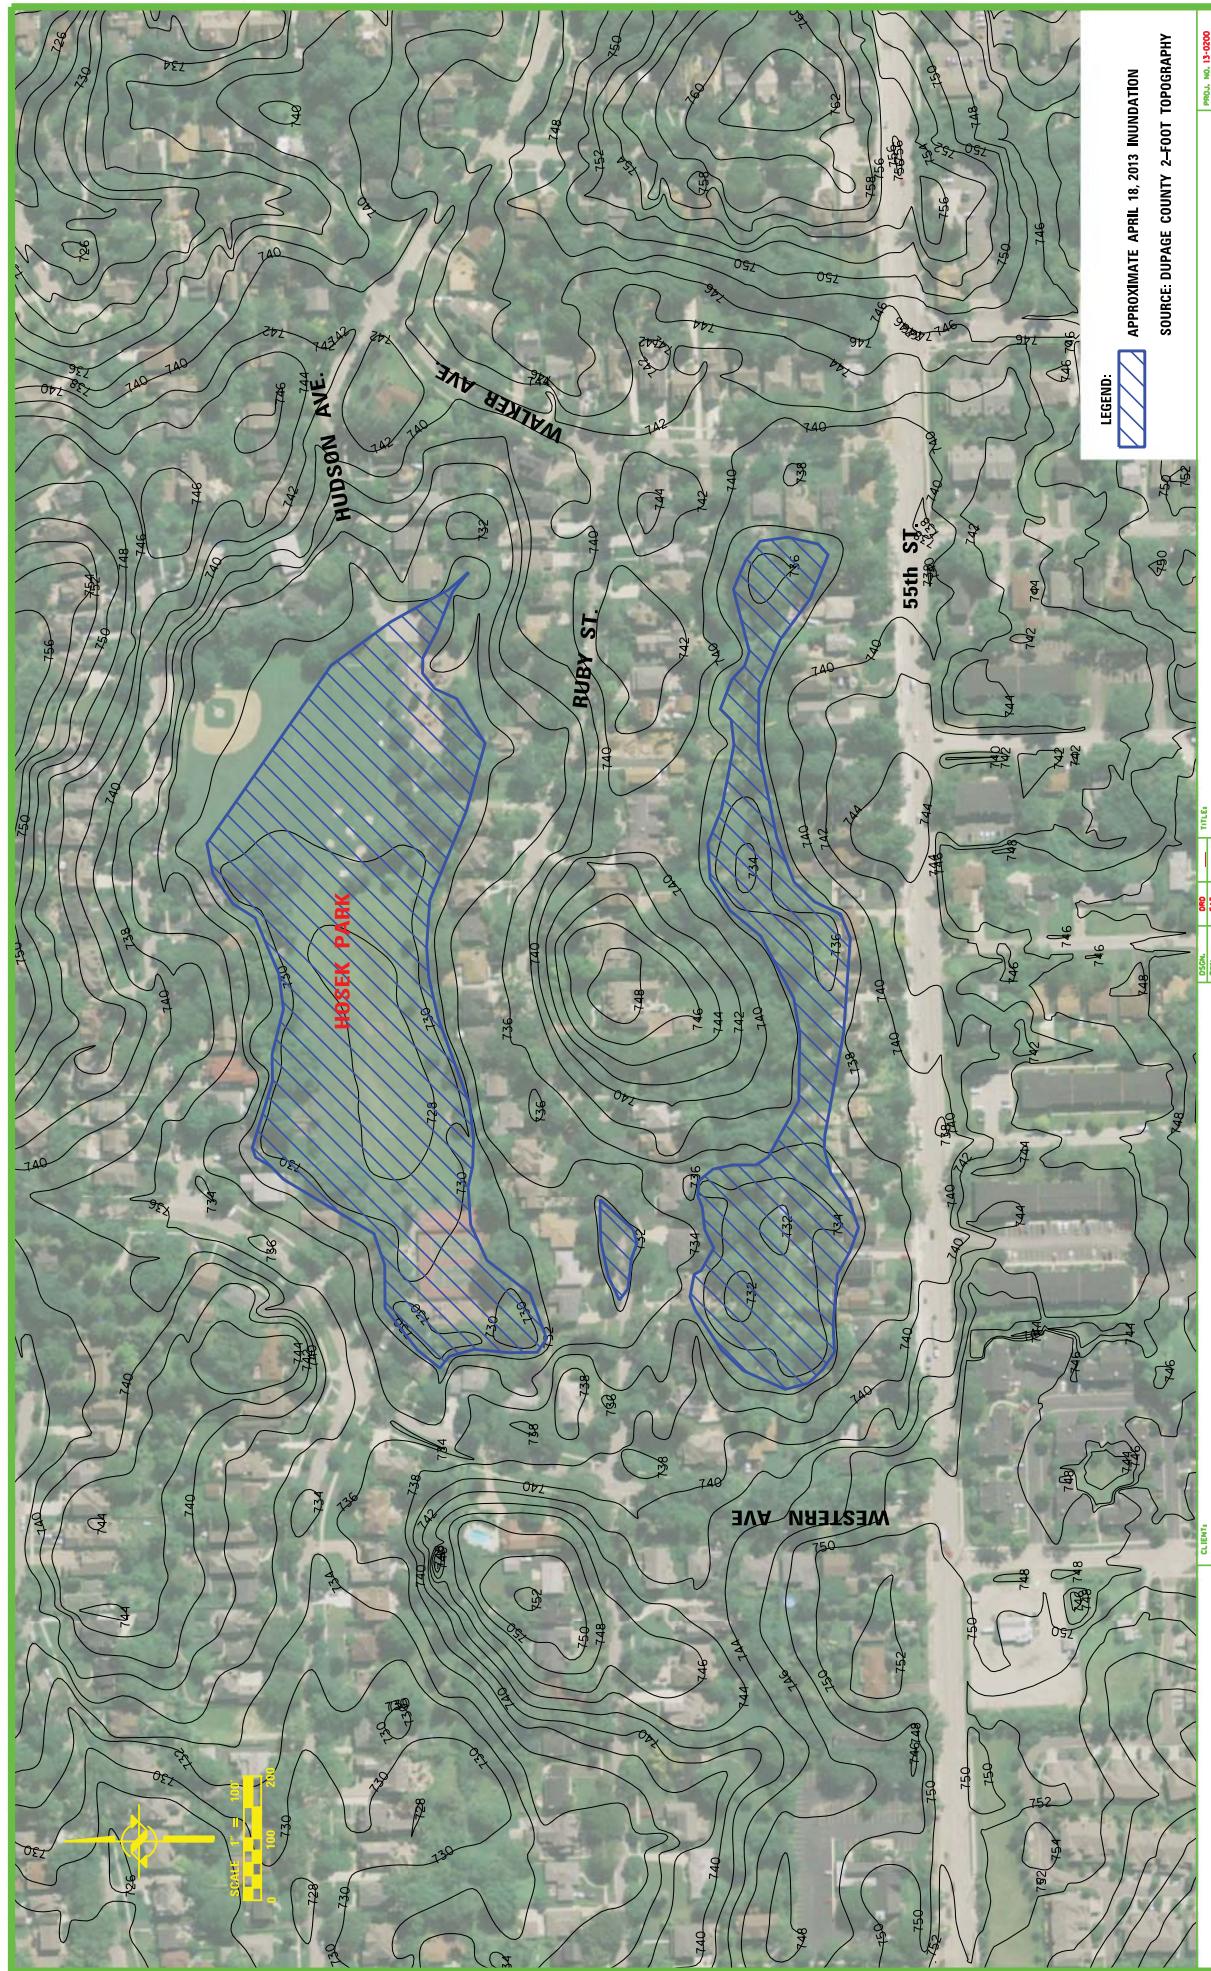
EXHIBIT 7

This area is located north of 55th Street, west of Walker Avenue, south of Ruby Street and east of Western Avenue. As the storm sewer system capacity is exceeded, inundation of the streets and yards of this area occurs. Excess stormwater from 55th Street has been reported to drain into this area. The surrounding inundation results in basement flooding through seepage and sewer backup. Yards of homes surrounding Hosek Park are also inundated when Hosek Park becomes inundated.
