VILLAGE OF CLARENDON HILLS

April 18, 2013 Storm Event

**Clarendon Hills, DuPage
County, Illinois**

CBBEL Project No. 13-0200

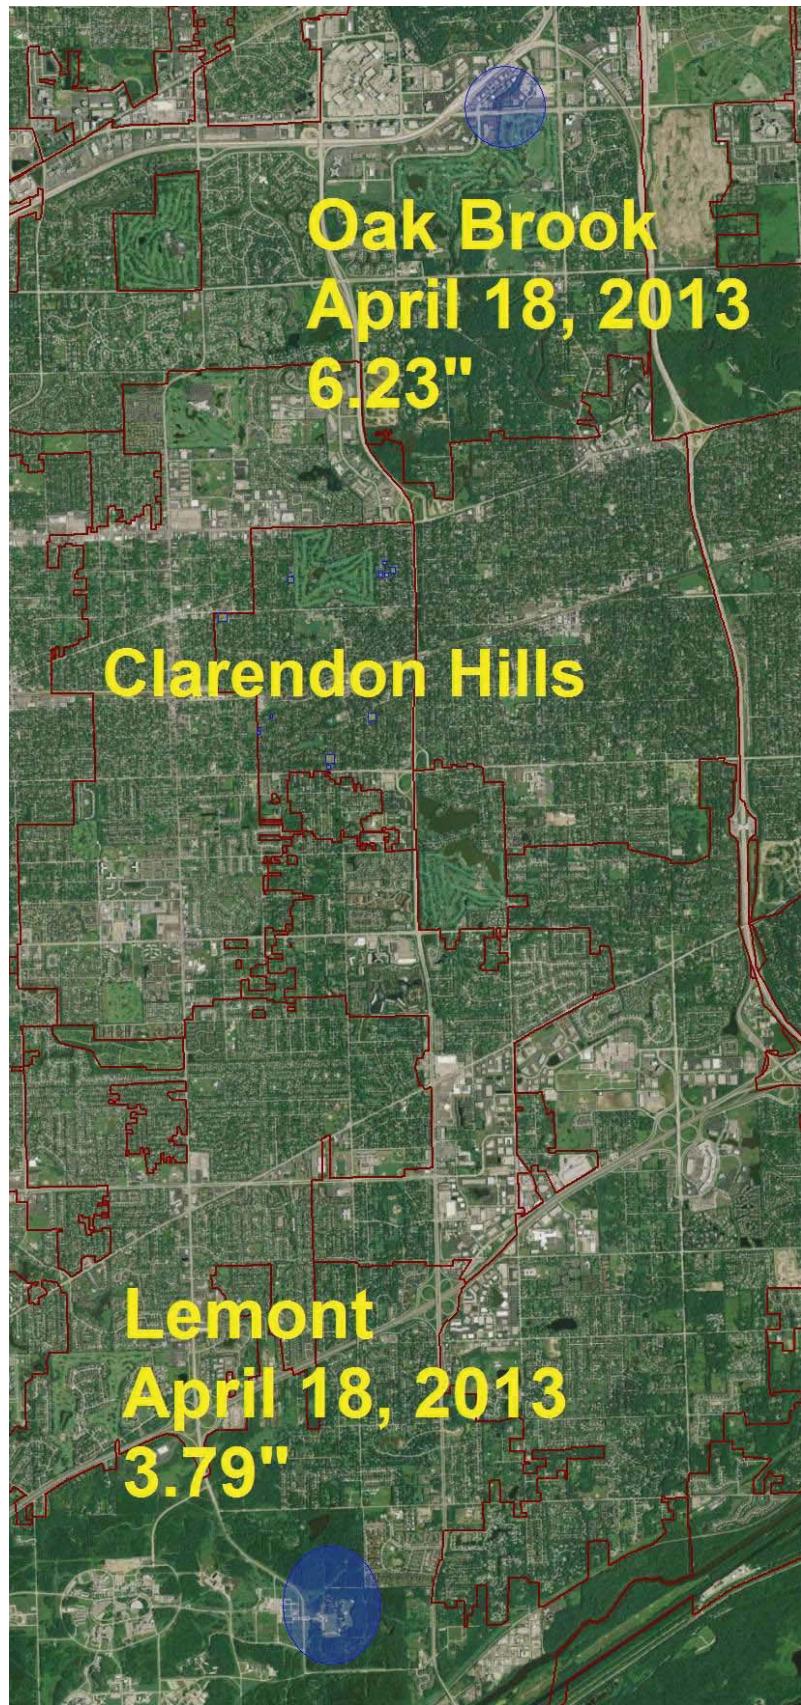
Figure 1 - April 18, 2013 Rainfall Totals

Figure 1 shows the locations of these rain gages.

Based on the reported street inundation depths and the inundation timing, it is our opinion that the Village experienced rainfall closer what was reported at the Oak Brook rainfall gage.
