DATE: July 25, 2023
To: Village Manager Creer
From: Brendan McLaughlin, Chief P. Dalen
Subject: Middaugh Sign Request

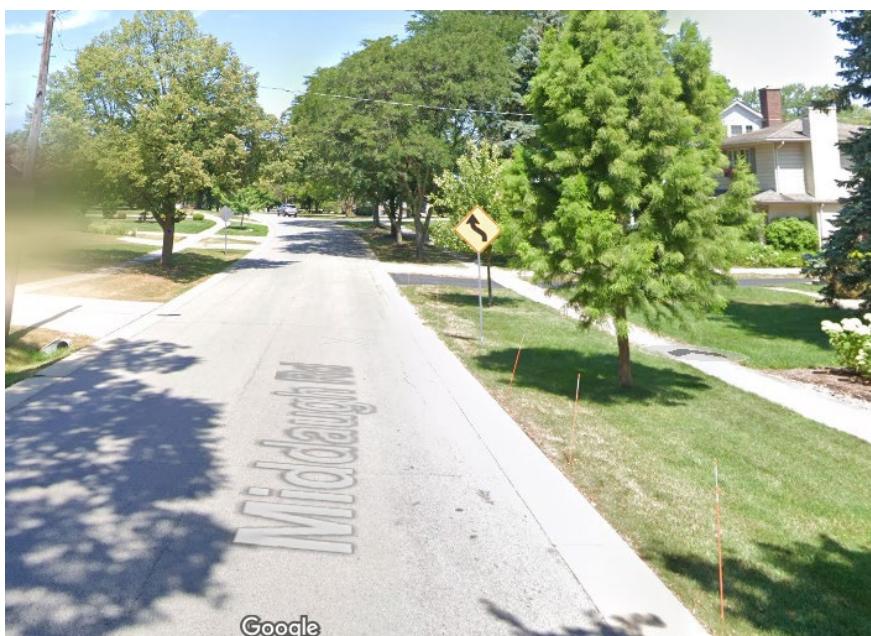
Middaugh is a residential street and has a speed limit of 25mph. Middaugh has a sidewalk on both the east and west side. Parking is restricted to one side of the street. There is a slight curve in the road near the recent crash sites. Curve ahead signs are posted prior to the curve for northbound and southbound traffic. Previous traffic data collected in the area shows the 85th percentile speed for northbound and southbound traffic to be approximately 28.96mph to 29.8mph

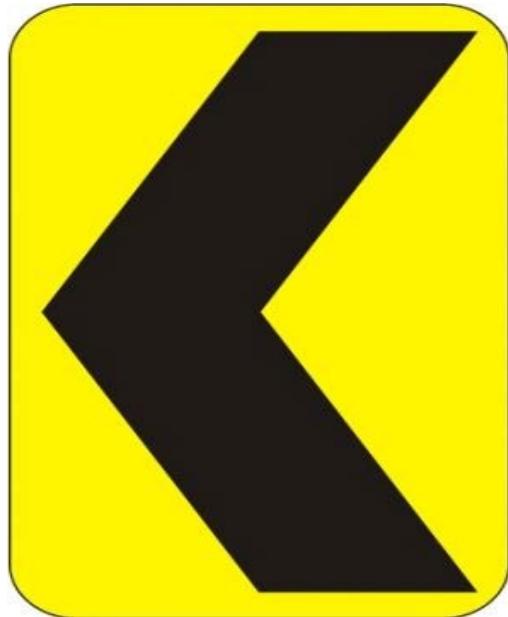
Christopher Burke Engineering was contacted to assess the curve on Middaugh Rd. for additional measures that may deter motorists from driving off the roadway. One suggestion was to post chevron signs (see below) along the east side of Middaugh for the northbound traffic. The engineer did note, however, that because of the low-speed limit, chevrons would be unnecessary and would probably not deter drunk drivers from veering off the road.

Staff concurs with the findings of the Village Engineers.
